NUMBER: 23-036-13

Noisy Side Windows

This bulletin involves cleaning and lubricating the window to regulator attachment point.

2007-2012	(PM)	Caliber
2007-2013	(MK)	Compass/Patriot

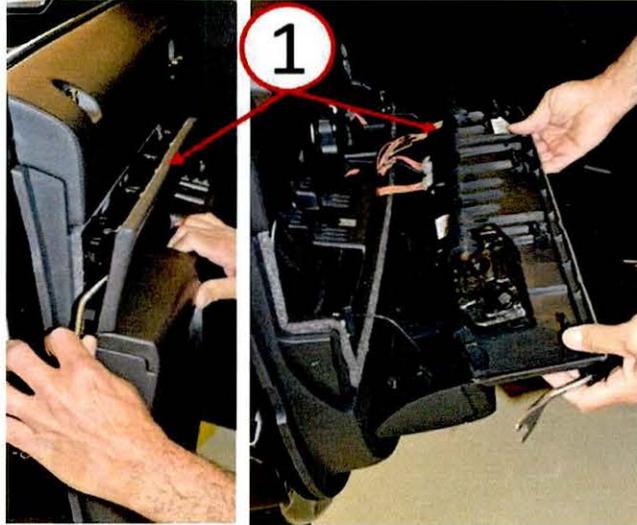
Fig. 1 Remove Door Bolster

1 - Door Bolster

1. Release the door bolster from the door(s) with noisy window glass. It is not necessary to remove the door bolster or disconnect the electrical connectors, bolster will be supported by the tether straps. For procedure steps to release bolster from door, refer to the detailed repair procedures available in: DealerCONNECT> TechCONNECT. (FRONT DOOR) 23 - Body> Doors - Front> PANEL, Door Trim, Bolster> Removal or (REAR DOOR) 23 - Body> Doors - Rear> PANEL, Rear Door Trim, Bolster> Removal (Fig. 1).

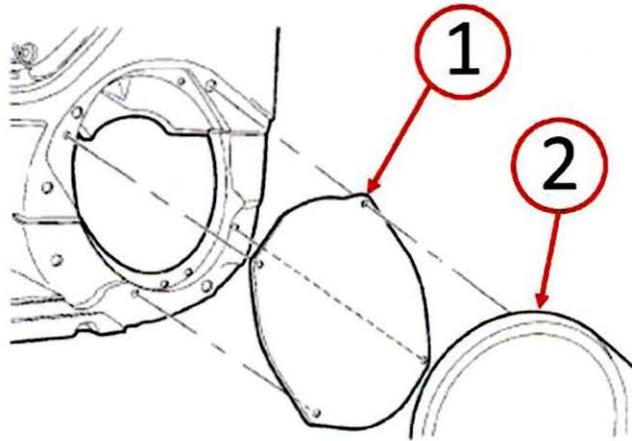
Fig. 2 Rear Door Speaker

- 1 - Door Speaker
- 2 - Speaker Grille

-
2. Rear door only, remove the speaker (1) for access to window glass lift plate. Refer to the detailed repair procedures available in: DealerCONNECT> TechCONNECT under: 08 - Electrical> 8A - Audio/Video/Entertainment/Connectivity> SPEAKER> Removal.

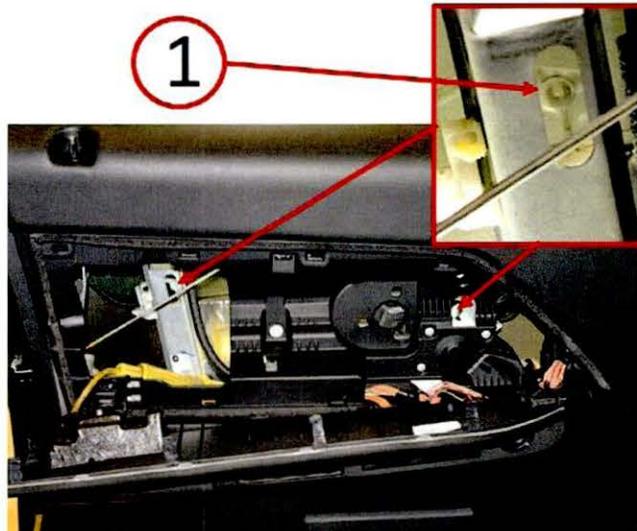
Fig. 3 Release Window

- 1 - Window Glass Retainer
-

-
3. Using a punch or equivalent, press tabs releasing window glass from window regulator lift plate. Front door shown, rear door has only one glass to regulator attachment point (Fig. 3).

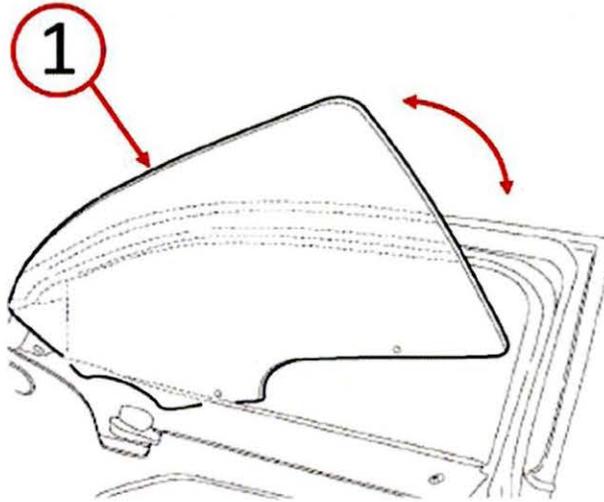
Fig. 4 Window Glass

1 - Window Glass

4. Rear door only, manually slide the rear door glass up in the window channel to position out of the way. Do not remove the rear door glass from the door window channel.
5. Front door only, remove the front door glass from the door window channel and carefully place it in a safe location (Fig. 4).

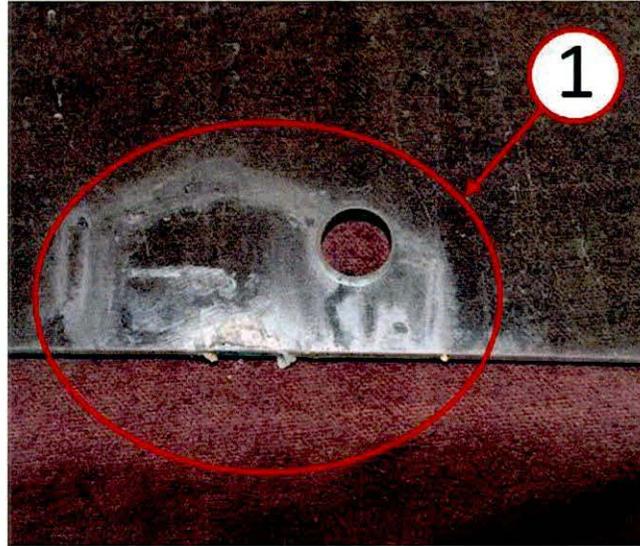
Fig. 5 Window Attachment Hole

During cycling of the side window(s) especially at full up stall, creak or squeak noises may be heard. Condition may be intermittent due to rain and/or vehicle washing. Vehicle owners in dusty environments may experience this issue more. Noise is caused by dust trapped between glass and window regulator liftplate.

1 - Dirty Window Glass

-
6. Using window cleaner and clean rags, clean all surfaces of window glass around window regulator attachment area including inside the attachment hole. Rear door window glass can be cleaned with window installed in door (Fig. 5).

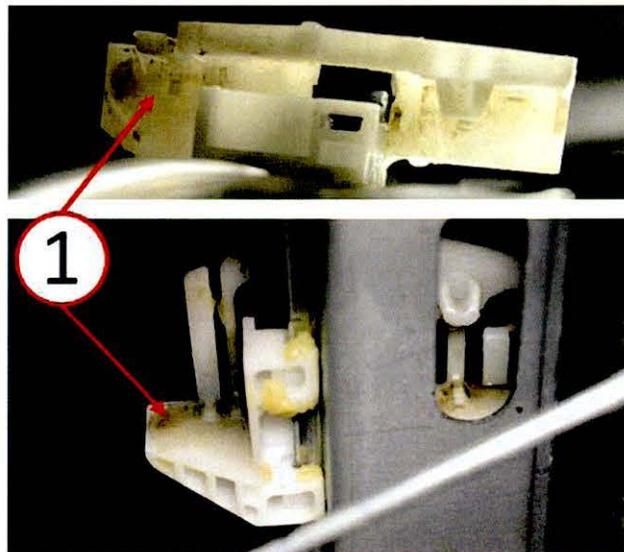
Fig. 6 Dirty Window Lift Plate

1 - Window Regulator Lift Plate

-
7. Using window cleaner and clean rags. Clean all surfaces of window regulator lift plate around glass attachment area including underside of glass retainer hook (Fig. 6) and (Fig. 7).

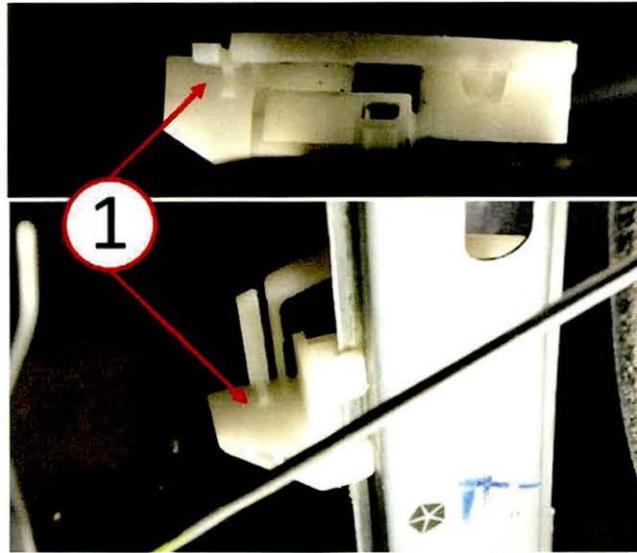
Fig. 7 Cleaned Window Lift Plate

1 - Window Regulator Lift Plate

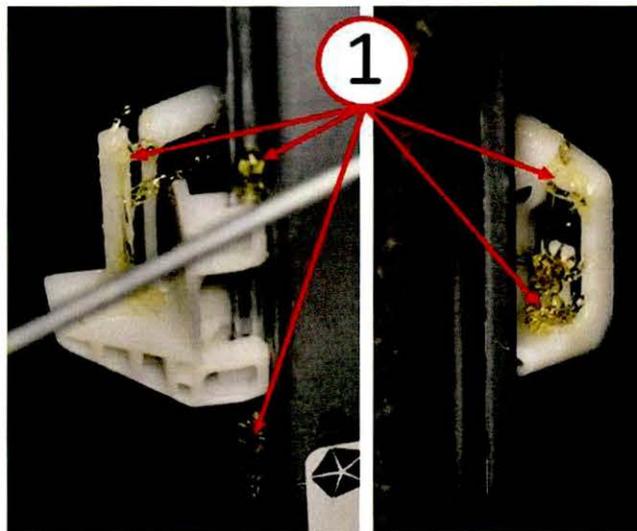
Fig. 8 Grease Window Lift Plate

1 - Lubricant Application Areas

8. Apply Nye® Synthetic Lubricant or equivalent to all glass contact surfaces of the window regulator lift plate, including the underside of the glass retainer hook. Also apply lubricant to the window regulator track above and below the liftplate (Fig. 8).

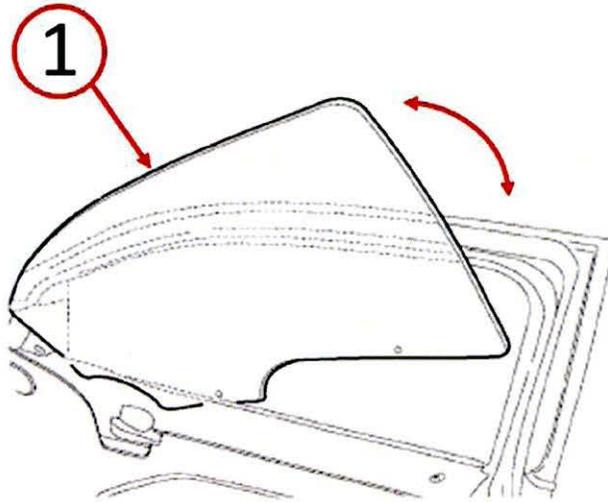
Fig. 9 Window Glass

1 - Window Glass

9. Front door only, install the door glass to the door window channel (Fig. 9).

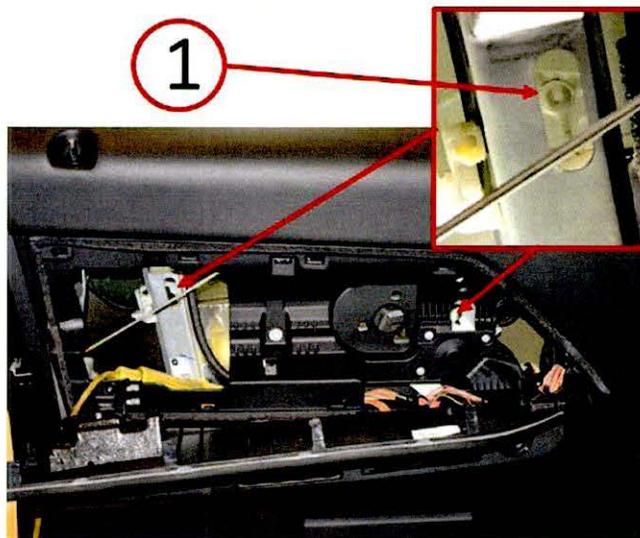
Fig. 10 Attach Window

1 - Window Glass Retainer

- 10. Secure the window glass into window regulator lift plate. Front door shown, rear door has only one glass to regulator attachment point (Fig. 10)

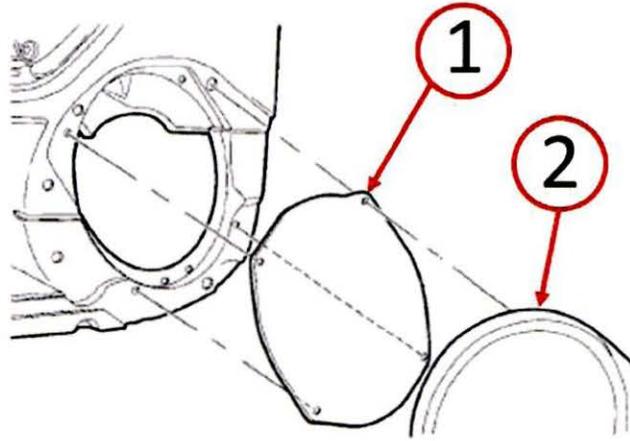
Fig. 11 Rear Door Speaker

- 1 - Door Speaker
2 - Speaker Grille

11. Rear door only, install the speaker (1) and speaker grille (2). Refer to the detailed repair procedures available in: DealerCONNECT> TechCONNECT under: 08 - Electrical> 8A - Audio/Video/Entertainment/Connectivity> SPEAKER> Installation (Fig. 11).

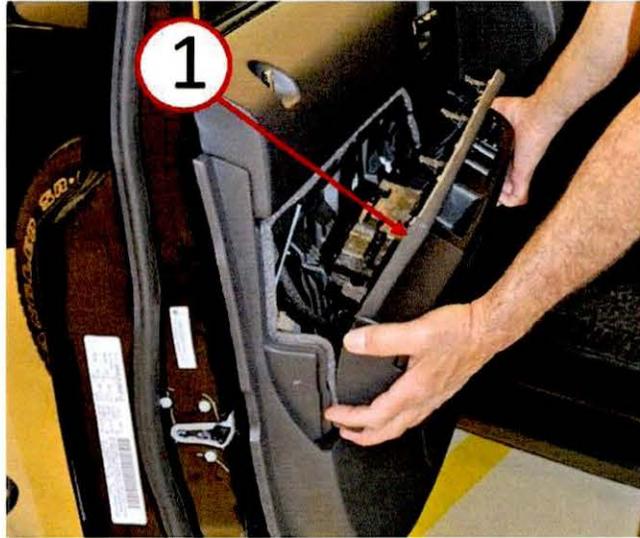
Fig. 12 Install Door Bolster

1 - Door Bolster

-
12. Install the door bolster to the door(s). Refer to the detailed repair procedures available in: DealerCONNECT> TechCONNECT. (FRONT DOOR) 23 - Body> Doors - Front> PANEL, Door Trim, Bolster> Installation or (REAR DOOR) 23 - Body> Doors - Rear> PANEL, Rear Door Trim, Bolster> Installation (Fig. 12)
